KATY CAMPUS ROOF REPORT

SUBJECT: ROOF SURVEY FOR KATY CAMPUS

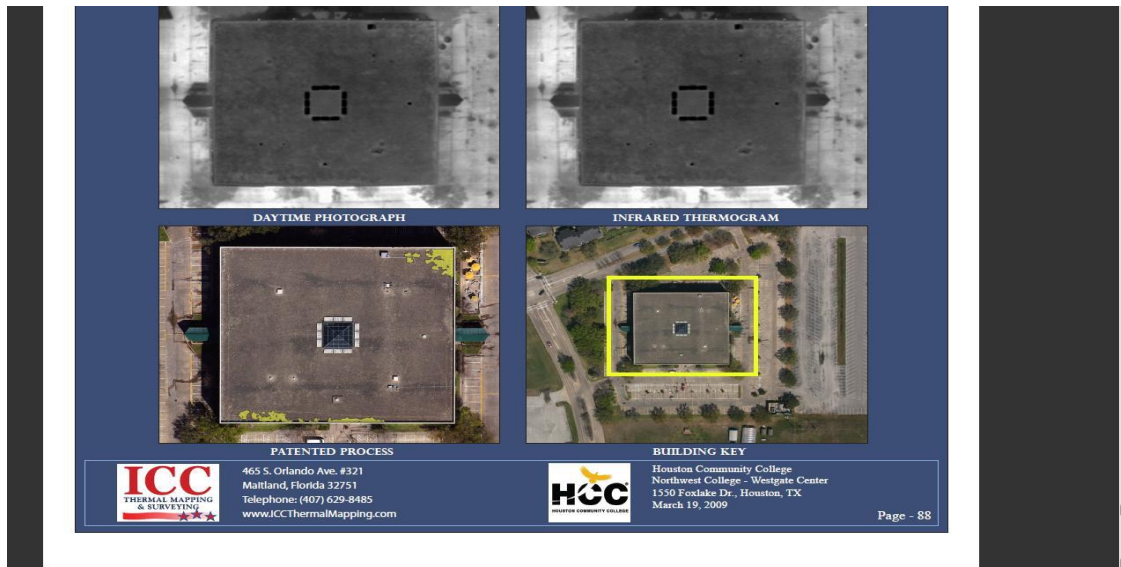
1.02.2 Roof Membrane: The membranes appear to be in good condition visually, however water infiltration has occurred into the facility around the perimeter of the facility. Refer to the infrared photographs

Yellow areas indicate moisture in the roof system.

Remove and replace both roof systems. Current building codes will allow a third membrane to be installed. Moisture is trapped in between the roof systems. Trapped moisture will cause additional water which may cause excessive weight. Excessive weight may possibly be a safety hazard to the students and staff below.

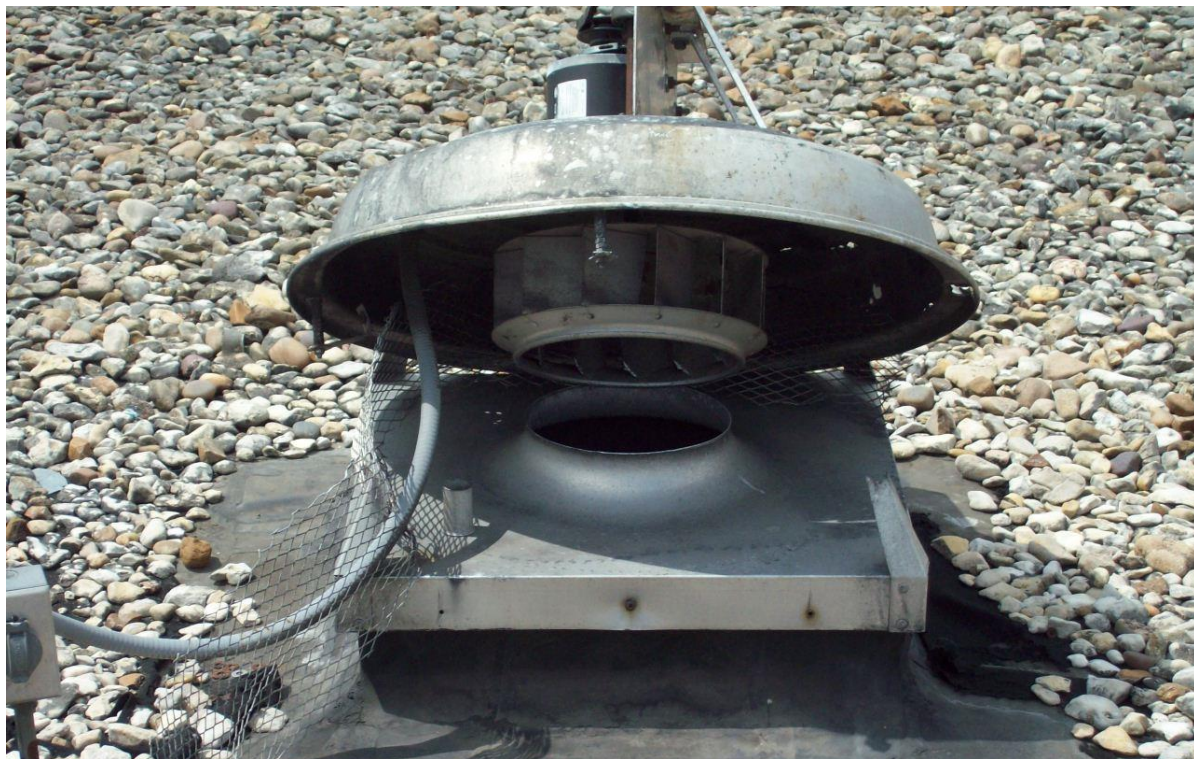
Damaged roof top equipment

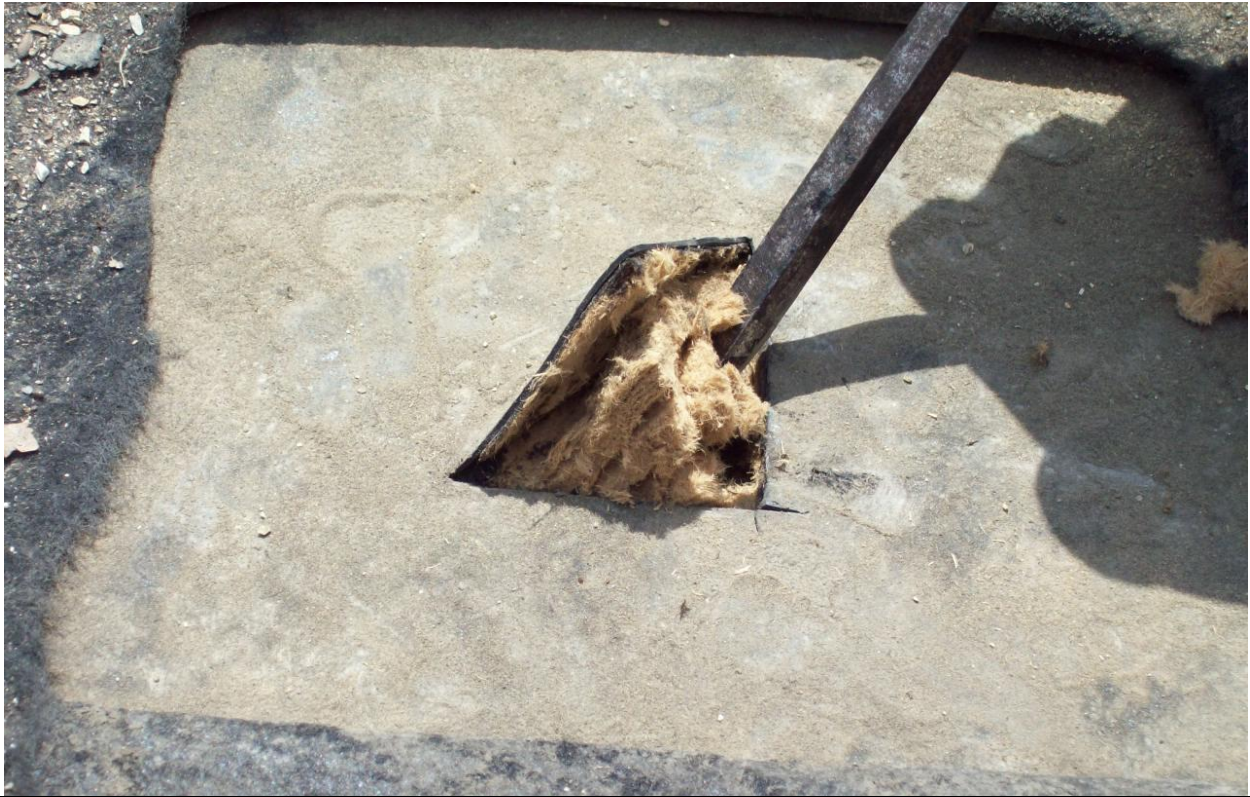
Core cut indicated wet below the first roof.
